# Rear Axle Failure Analysis of the Dump Truck

## Abstract

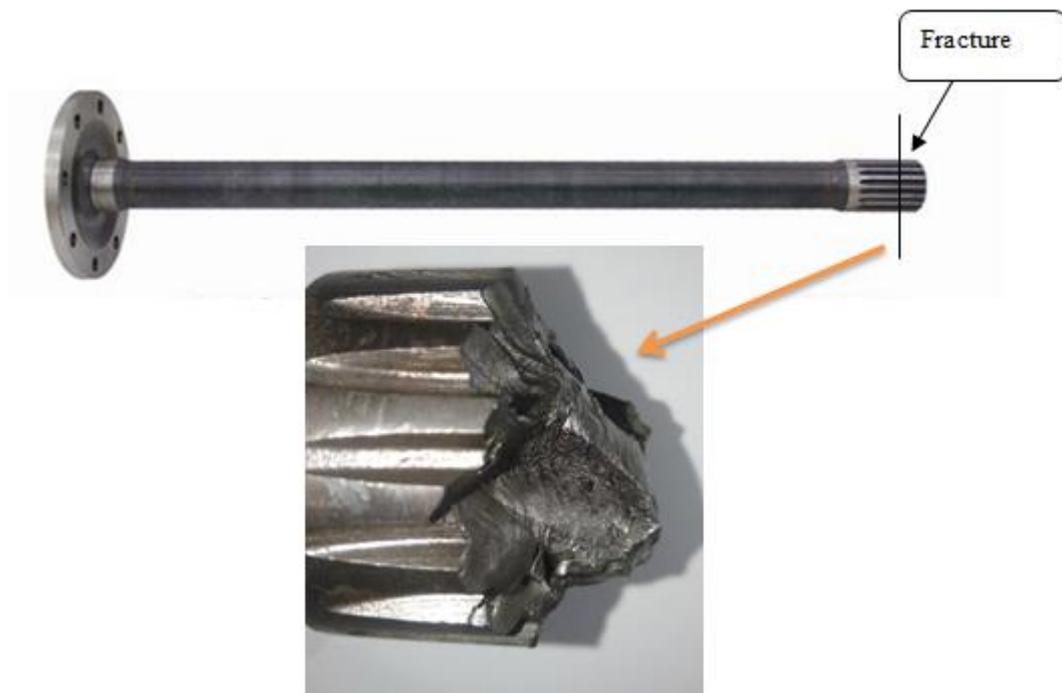
**Figure 1:** The Broken of the Axle Shaft whos Connected with a Differential Gear

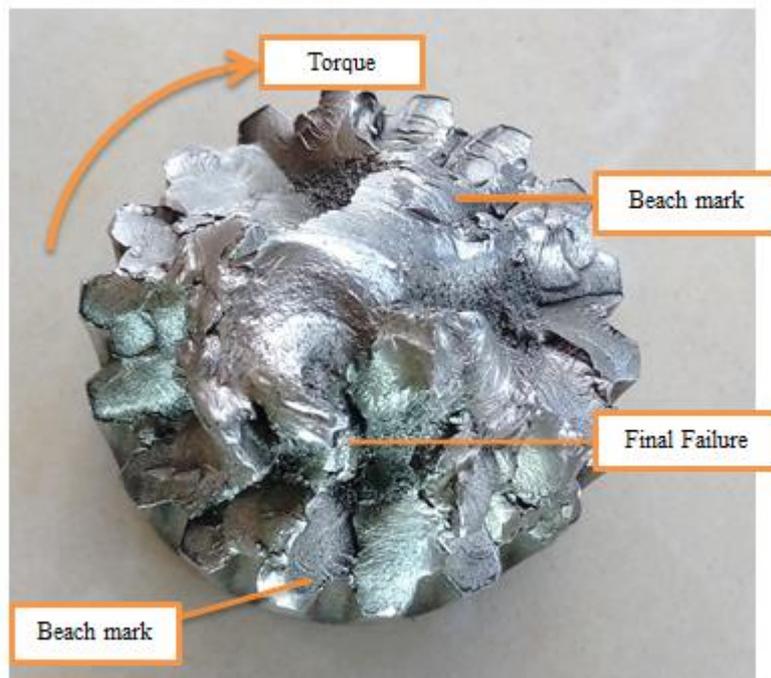
From the results of the macroscopic analysis it is seen that the crack initiation on the shaft starts from the edge of the shaft towards the center of the shaft as evidenced by the shape of the spiral in the center of the shaft that has failed. In the figure 2 there is a beach mark that is evenly distributed from the edge to the center of the shaft and the combination of slow crack propagation (dull and fibrous areas) and rapid crack propagation (areas that are shiny and slippery) indicates the shaft accepts dynamic loads.

**Figure 2:** Cross Section of Broken Shaft

The crack initial is indicated by striation and beach mark in the area around the crack initiation at the fault edge and appears to be rougher, while the beach mark is indicated by fine semi-circular lines in the initial crack area to final failure. Beach marks also called to be crack propagation stages. The area between the crack propagation stage and the final stage can quantitatively show the magnitude of the stress acting. If the area of the crack propagation area is greater than the area of the final fracture, the working stressing is relatively low, and vice versa if the area of the crack propagation is smaller than the area of the final fracture, the working of the

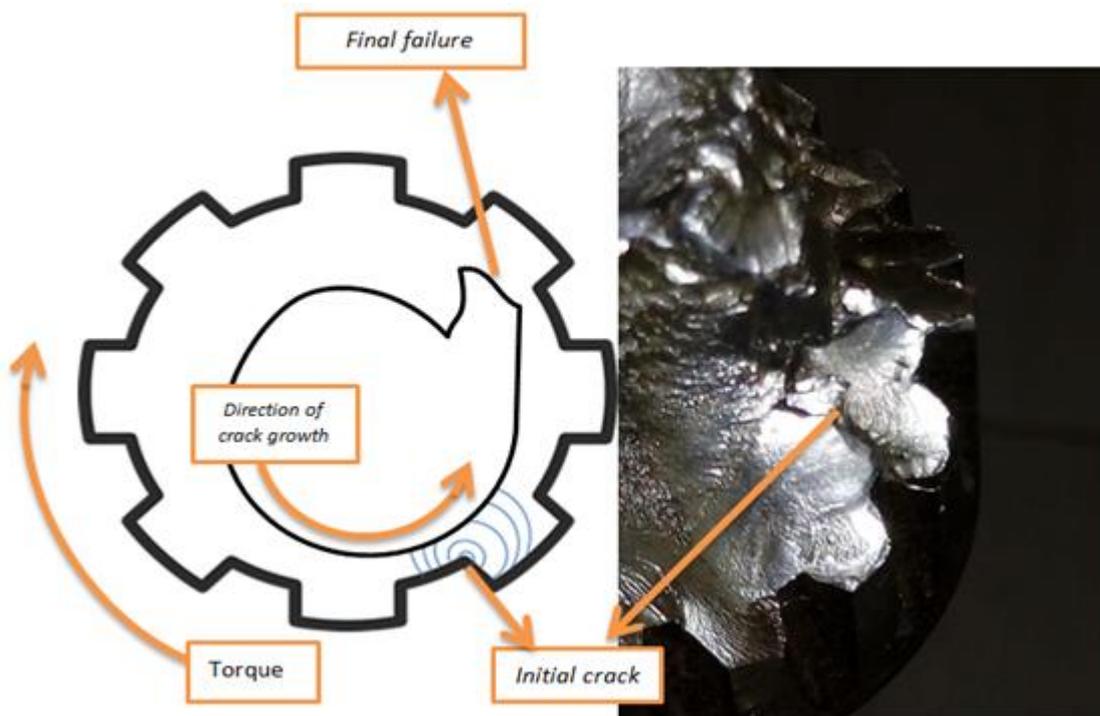
**Figure 3:** Initial Crack and Direction of Crack Growth

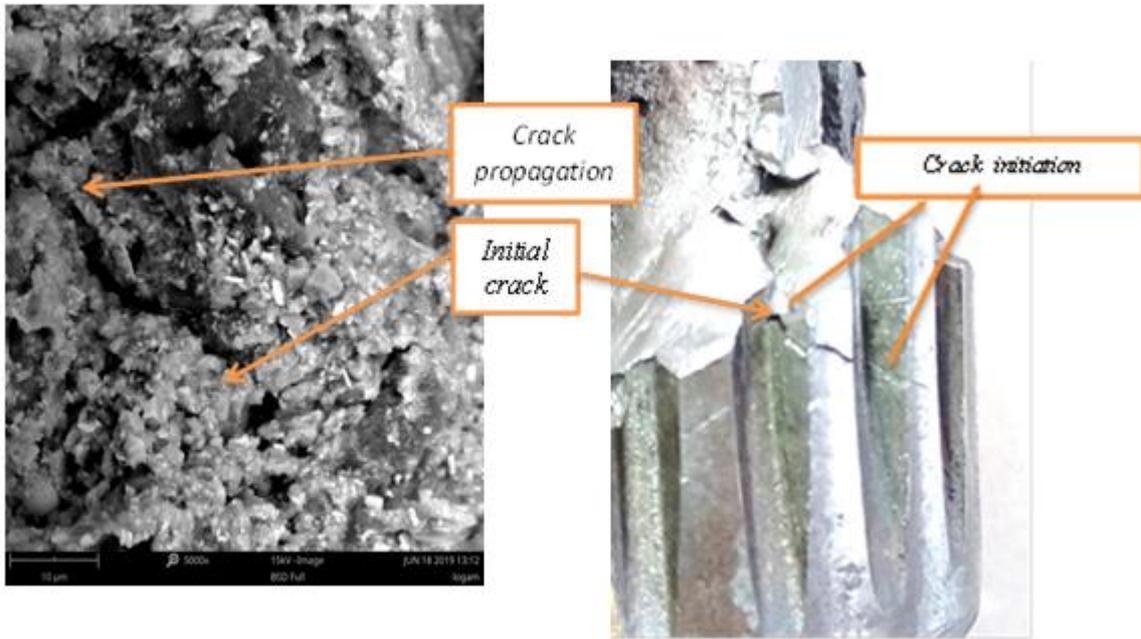
**Figure 4:** Crack Initiation and Crack Propagation

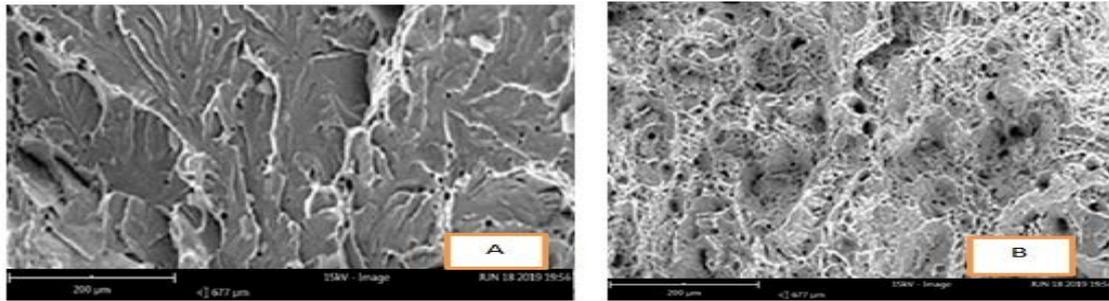
Fractography on the surface of the shaft can be seen as a V-shaped cleavage on the surface fracture, certainly broken because on brittle mode. While the fracture on the core of the shaft shows the shape of the dimples on the fault. Ascertained is an elastic type of fault. The fracture surface assessment identified several characteristics of fatigue failure characteristics: (i) a beach mark sign that is a sign of development of fatigue front cracks and (ii) a ratchet mark which is a sign of crack initiation due to high stress concentration. The exact mechanism of fatigue is always consistent with unidirectional bending. Eg: [6]

**Figure 5:** (A) Fractography analysis of the edge of the failed component; (B) fractography analysis of the core of the failed component.

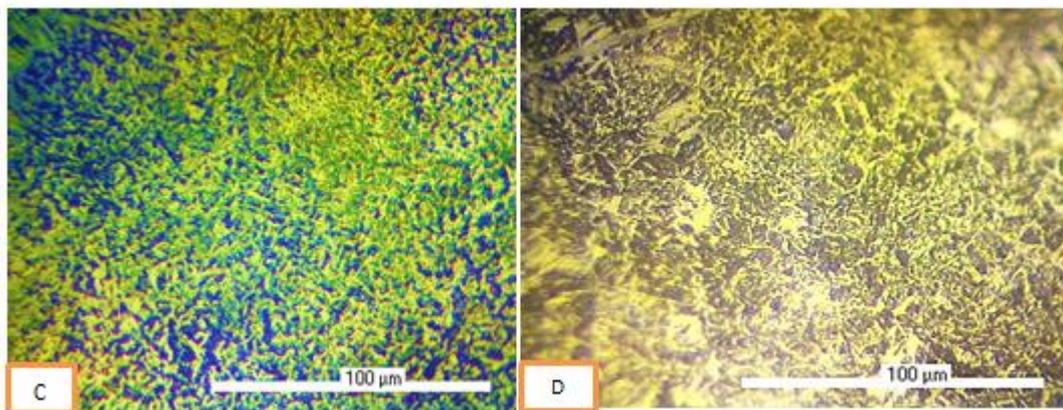
**Figure 6:** (C). Microstructure of the edge of the component 600x, (D). Microstructure of the core of the component 600x

Microscopic analysis on the shaft surface, Figure 6 C and 7 C, show that the martensite phase is uneven tends to be grouped. There is a ferrite-pearlite phase on the sidelines of a martensite group, indicating the temperature at the surface hardening process is unstable. The matrix area shows that the dominant martensite phase is rough and sharp so that it can be concluded that tempering is carried out at high temperatures and quite a long time and is quenched quickly. This grouped and uneven martensite phase results in uneven surface hardness of the shaft.

Analysis of the core of the shaft, figure 6 D, show the dominant ferrite and pearlite phases. It was concluded that the core of the shaft was more resilient than the surface of the shaft which was dominated by the hard bainite and martensite phases.

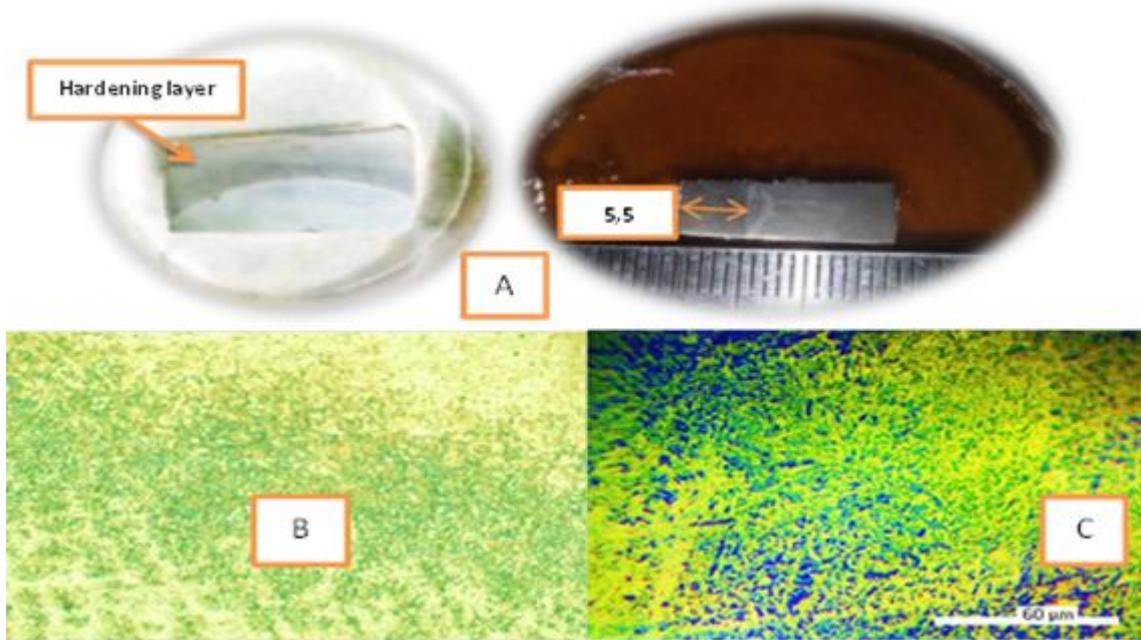
**Figure 7:** (A). Macrostructure of the cross section of the failed shaft, (B). Microstructure of the edge of the component 50x, (C). Microstructure of the edge of the component 600x

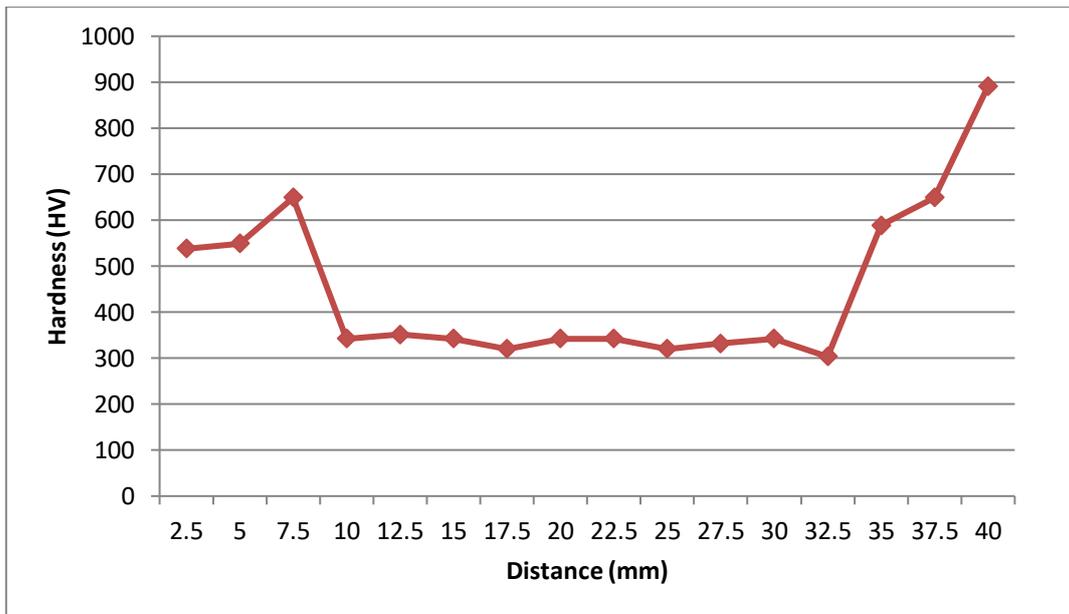
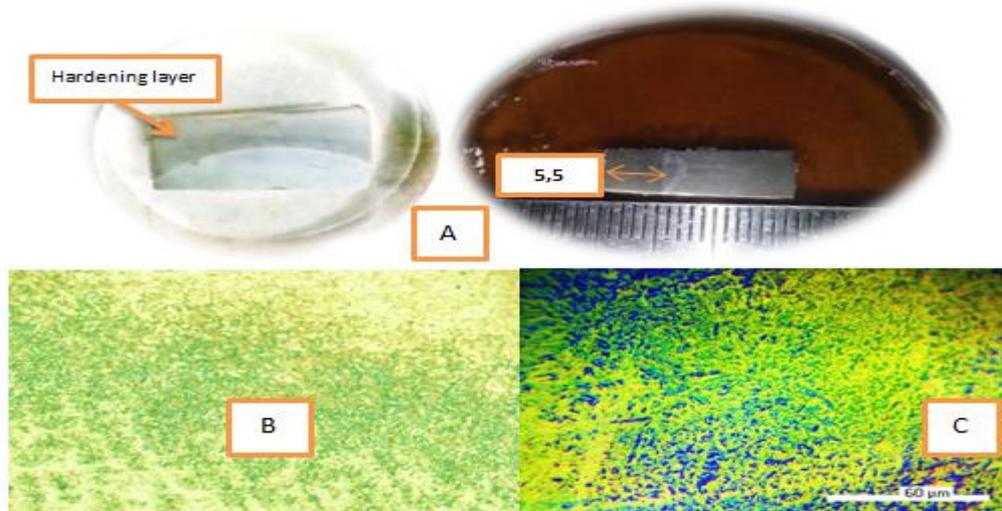
**Figure 8:** Rear Axle Hardness Distribution A

The distribution of the hardness values observed in Figure 8 does not look uniform. Surface hardness on different left and right sides is different, namely 538 HV and 891 HV indicating that surface hardening is not evenly distributed on the shaft. The distribution of the hardness value observed in Figure 9 There is a fluctuation in the value of hardness which is tested 2 mm from the edge (surface) by 40 circular points using a Vickers hardness tester. The highest hardness value is 885 HV and the lowest is 548 HV.
